**ARKANSAS LEVEE STABILIZATION PROJECT
PHASE I**

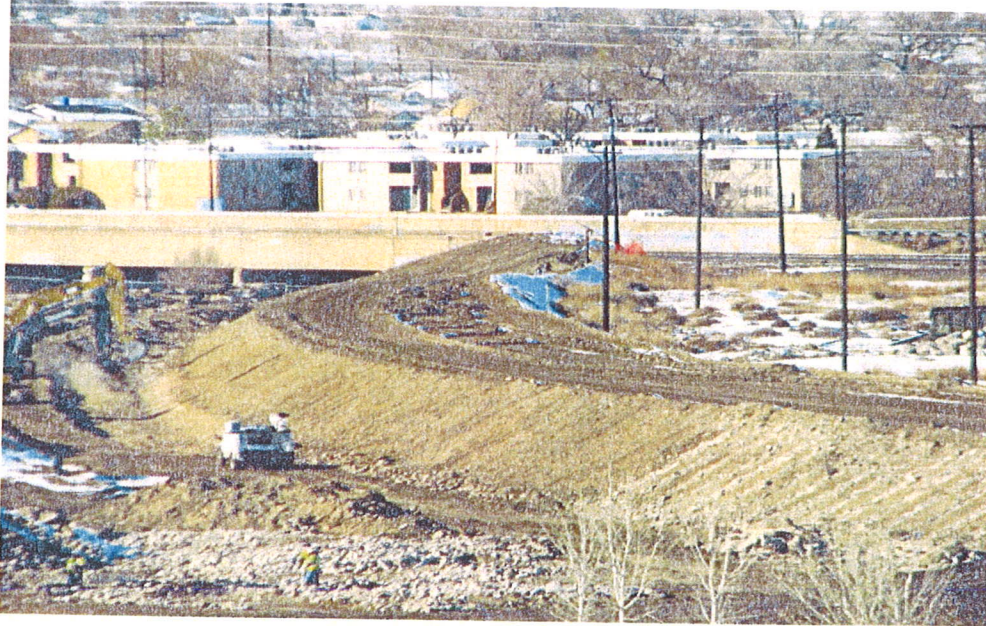
Levee work looking NW from Dutch Clark Stadium
Crushing operation is located in lower left; Access ramp to the top of the levee lower right. Slopes are being rough graded and the top of the Levee is being graded for the maintenance road. Picture was taken on January 22nd.

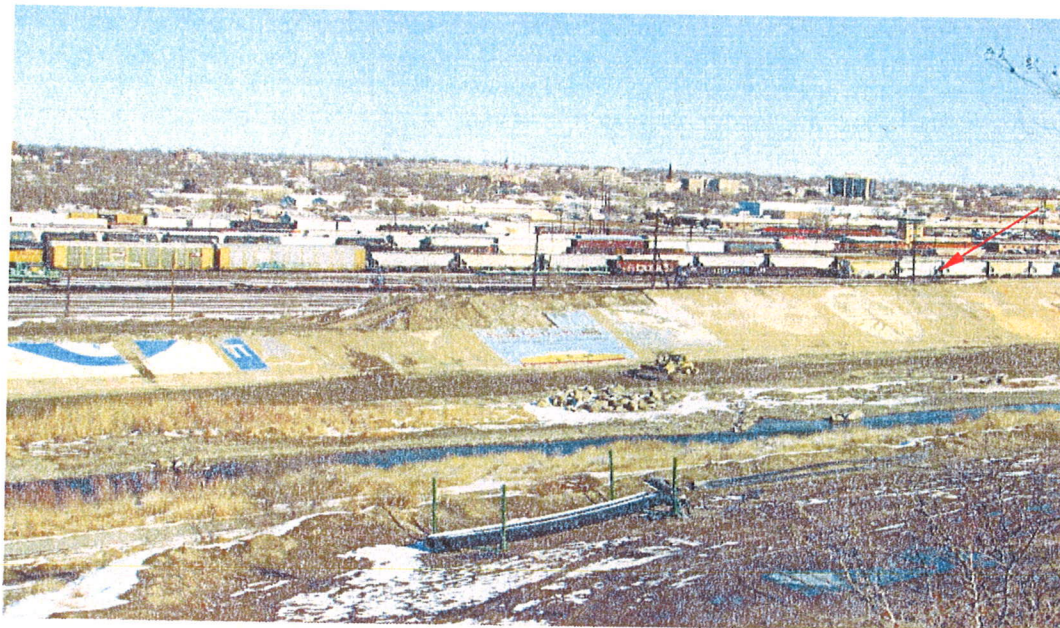
Levee work looking SE from Dutch Clark Stadium
This picture was taken on January 22nd showing the progress near the end of Phase I (red arrow). The bottom of the levee has been graded along the toe in preparation for the work in the river.

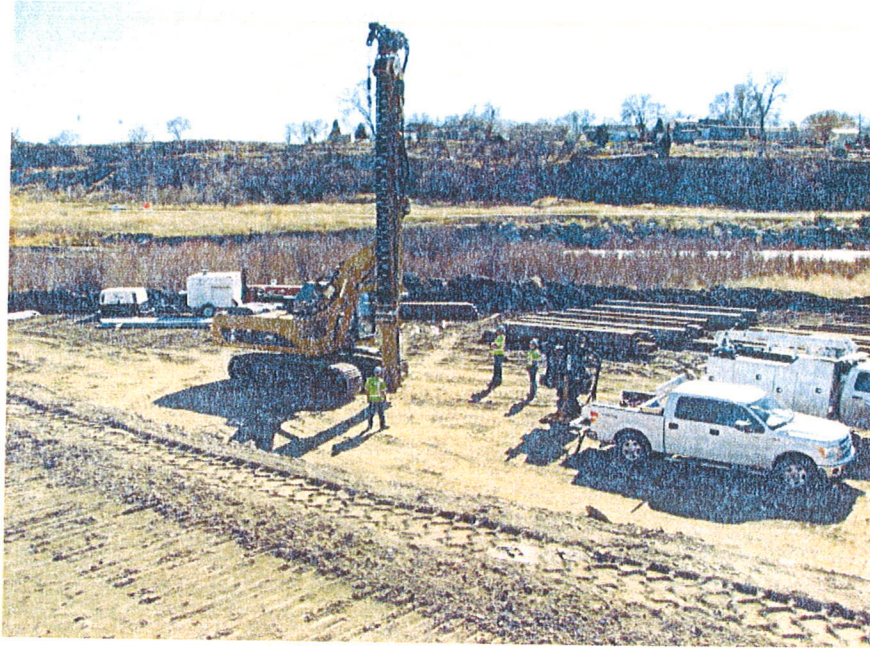
Pile Driver and Sheet Pile

Pile driver arrived on site on January 26 and was being inspected by ASI Mechanics prior to work starting on January 27. Sheet Pile is shown in the background.

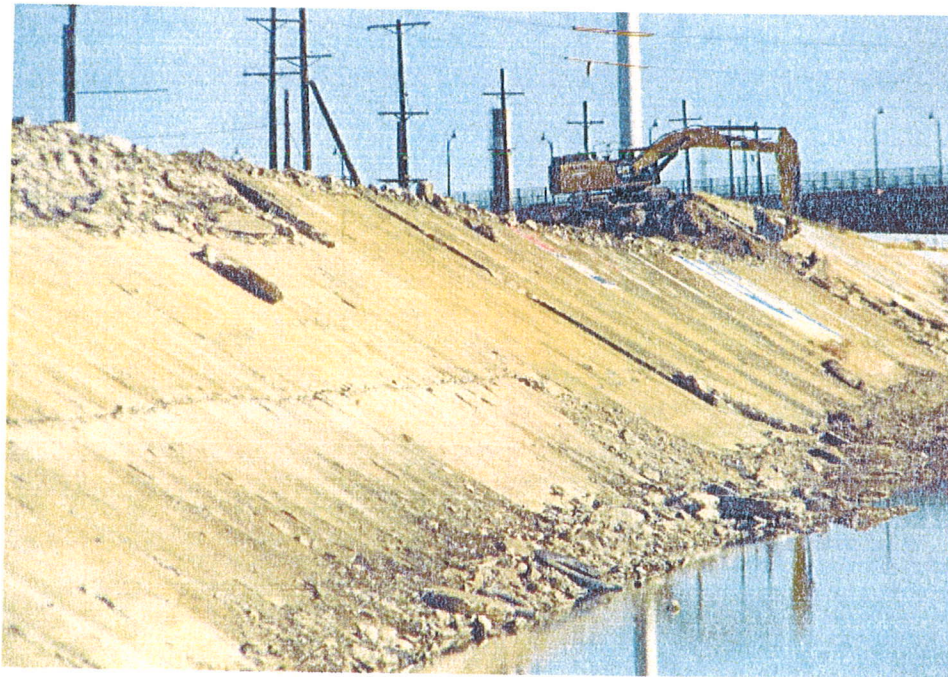
Excavation and Panel Removal

A Track Excavator doing double duty excavating the overburden at the top of the levee and removing panels near the end of the project.

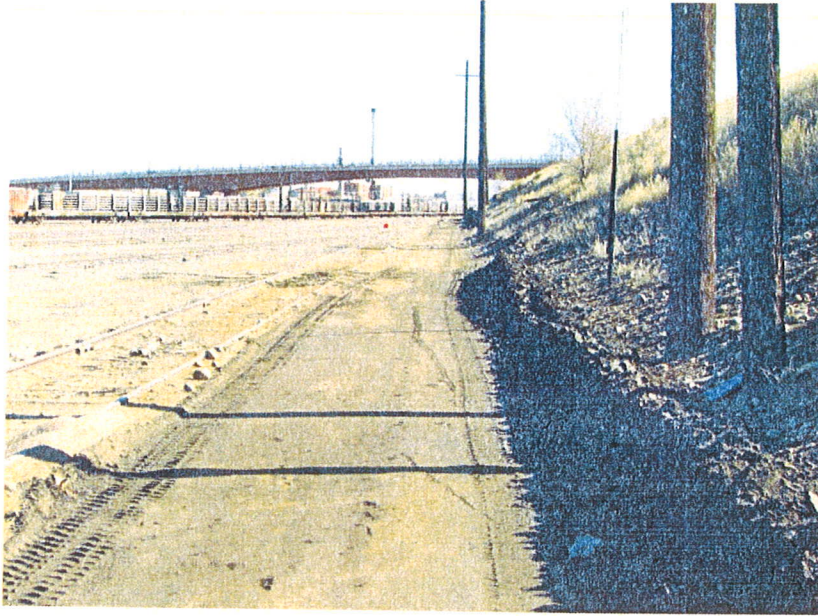
Toe of Levee along the Rail Yard

Work along the toe of the levee on the “dry” side (adjacent to rail road tracks) is being done as that same time as work on top of the levee. Care has been taken to keep the access road used by rail yard employees clear of rubble that slides down the slopes during excavation of the overburden.

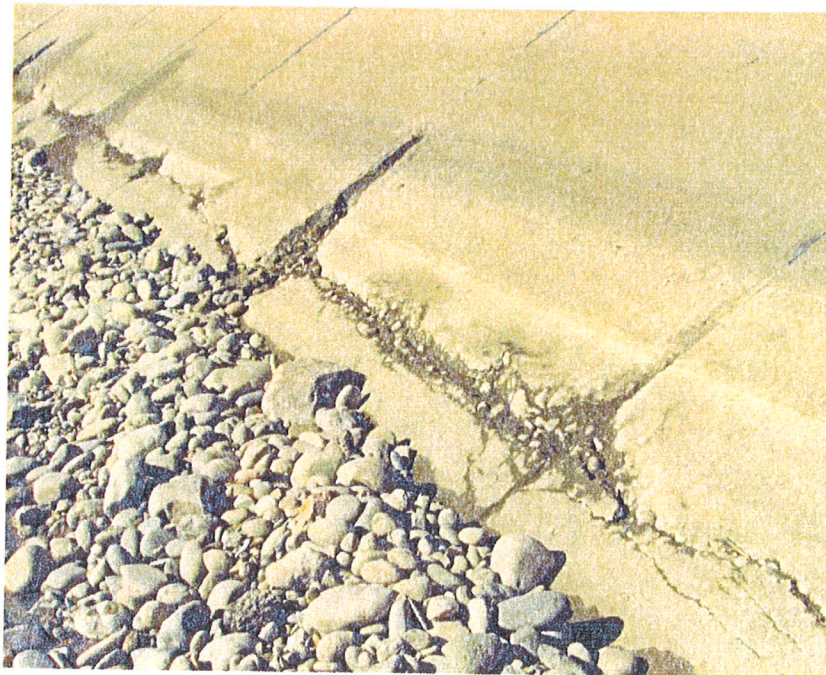
Toe of the Levee below water level.

Deterioration of the Levee that was exposed after the Aqua Dam was installed and the water level dropped. A horizontal gap that runs 600 feet along the toe was exposed along with several areas of erosion and cavitations at the construction joints.

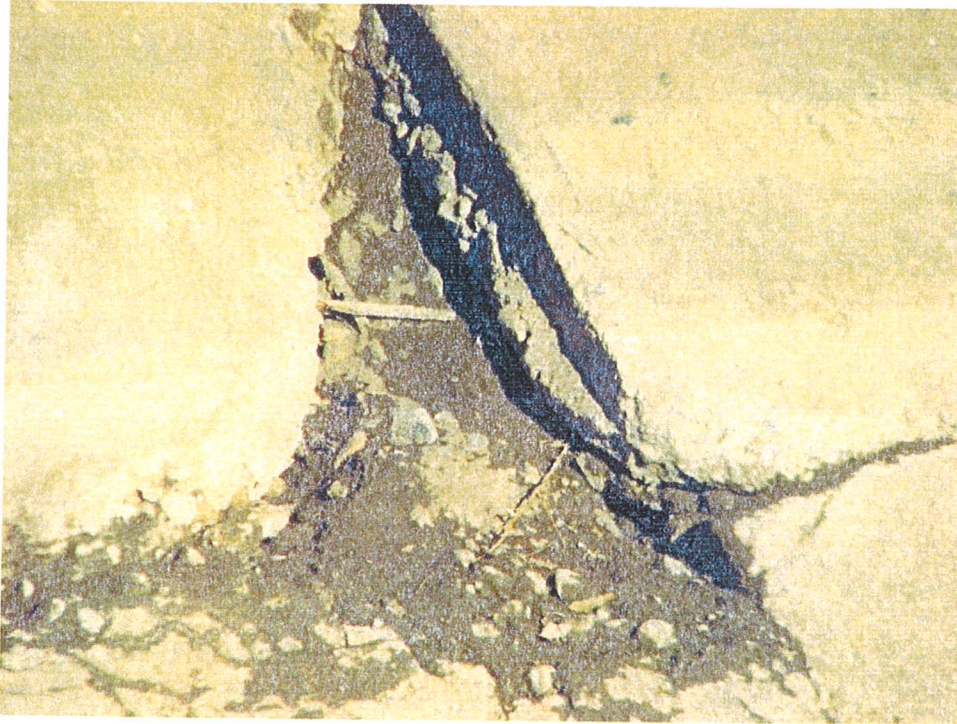
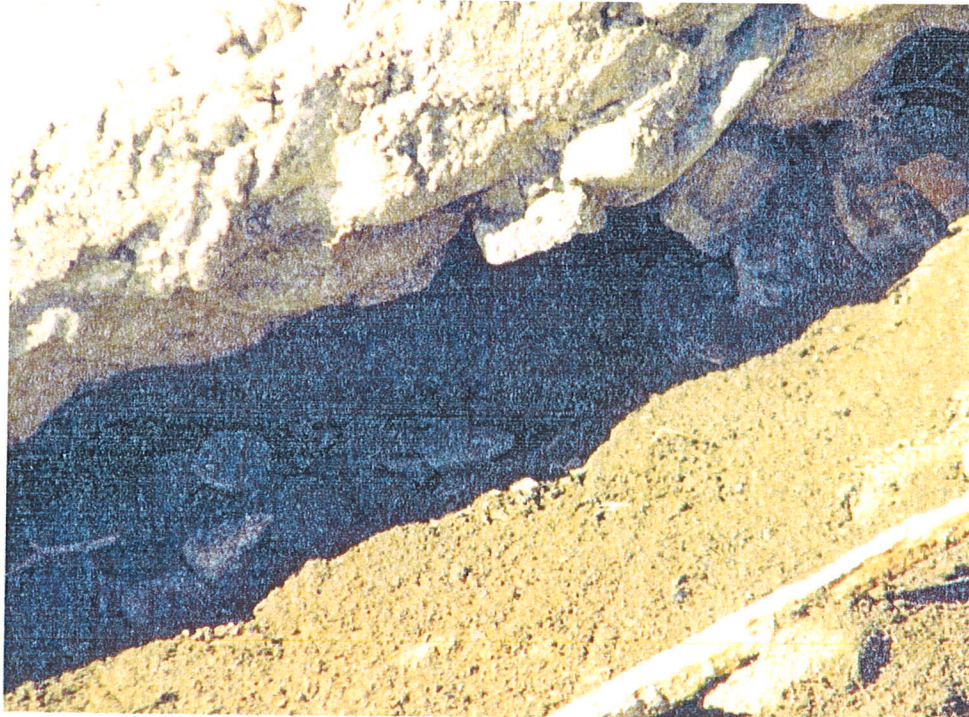
Deterioration at the construction joints and keyways

Two pictures showing the deterioration of the joints and keyways along the toe of the levee that were evident after water level dropped. The re bar is corroded or nonexistent in these areas along with voids under the concrete. Similar voids have been exposed in the upper portions of the levee as the panels are being removed.
